Thermcraft CoilCraft Element System (CCES) Conversion

In mid 2006, Perryman Company (a Western PA metals producer) issued an order to Thermcraft Inc to produce a series of drying ovens for processing metal scraps as part of a proprietary process developed by Perryman. Based on the specifications developed during the initial discussions, Thermcraft supplied units that employed its standard PH-C series heavy-duty cast plate heaters mounted under the client supplied process unit.

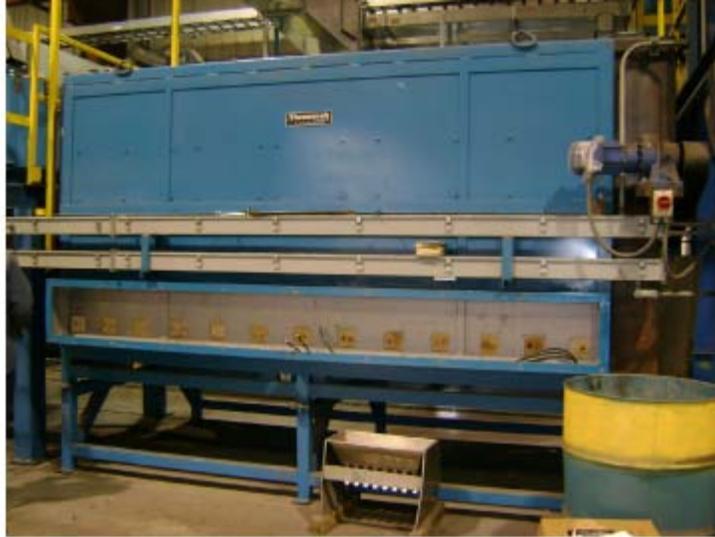
**Original Thermcraft Drying Oven
Terminal Compartment Open**

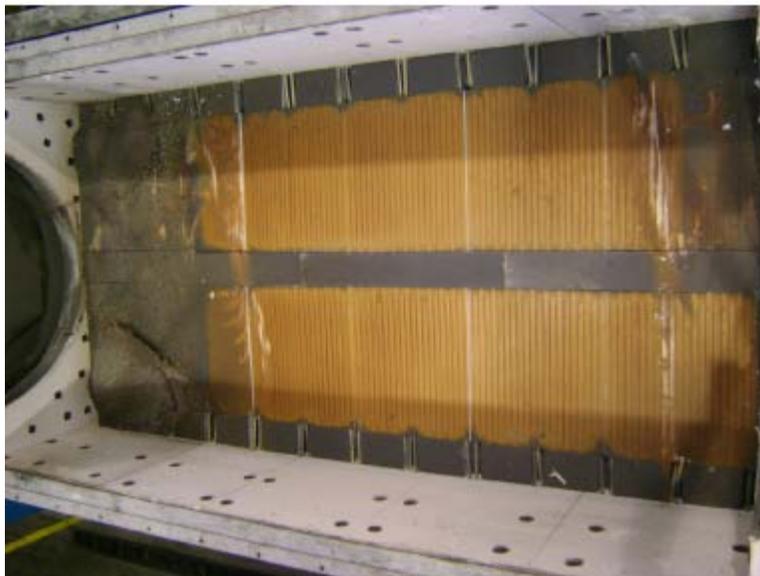
The units worked quite satisfactorily for a couple of years. At that time, Perryman added process air to assist in removal of volatiles given off during processing. The process air added an additional loading factor to the heaters and contributed to metals fines contaminating the heater compartment. Both issues contributed to heater failure at both ends of the chamber where contamination was the greatest. A new set of replacement heaters was installed but the end heaters failed again in approximately six months. A second set of heaters suffered a similar fate. Since the top of the furnace and the rotating drum had to be removed to enable heater replacement, a considerable amount of expense and downtime was involved in addition to the cost of replacement heaters.

**Heating Element Compartment
Showing Product Contamination
at Both Ends of Furnace**

After reviewing several options, it was decided that Thermcraft's CoilCraft Element System (CCES) was the most practical option to solve the above problems. This system is essentially a heavy gauge wire element combined with a ceramic support structure. For this particular application, leads were designed so that both would exit the same side element end, allowing for insertion or removal of each individual heater without any disassembly of the furnace other than to open the terminal compartment and disconnect the power leads to that heater. Thermcraft was also able to develop a design having a slightly lower watt loading on each element, which typically translates into a longer element life. The design would ensure balanced three phase power would be maintained and provide interlocking shields to protect against contamination of the element due to product dust escaping from the process unit.

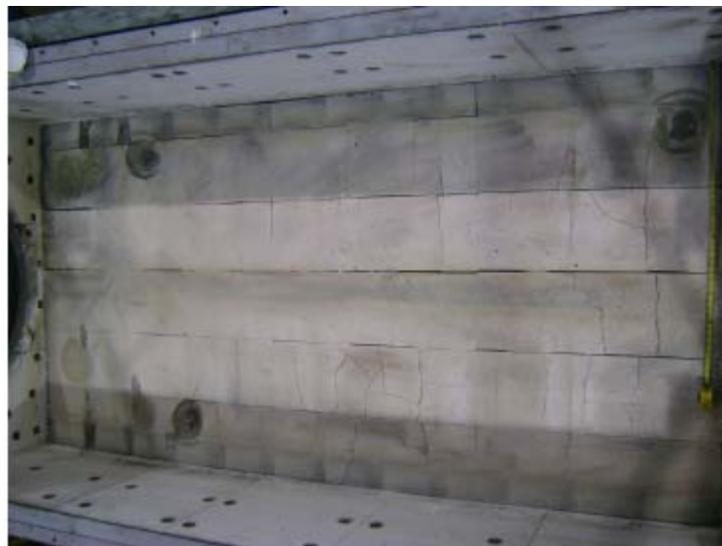
It was further agreed that Thermcraft would supply the heaters, support system, and engineering and construction drawings along with detailed instructions while Perryman would do the actual conversion. Upon receiving the materials, Perryman started disassembly during which an additional problem was discovered. Due to the nature of some heater failures, the underlying insulation had been damaged and required replacement.

**Damage to Insulation From Plasma Flash
During Certain Element Failures**

Once damaged insulation was replaced in the base of the furnace, the actual conversion process began. One of the first changes was to cut away sections of the steel furnace shell in the terminal compartment, without damaging structural integrity of the furnace, so passage holes for the new element system could be drilled through the sidewall insulation. The locations and cutout areas were part of the information package provided by Thermcraft to insure proper alignment and strength.

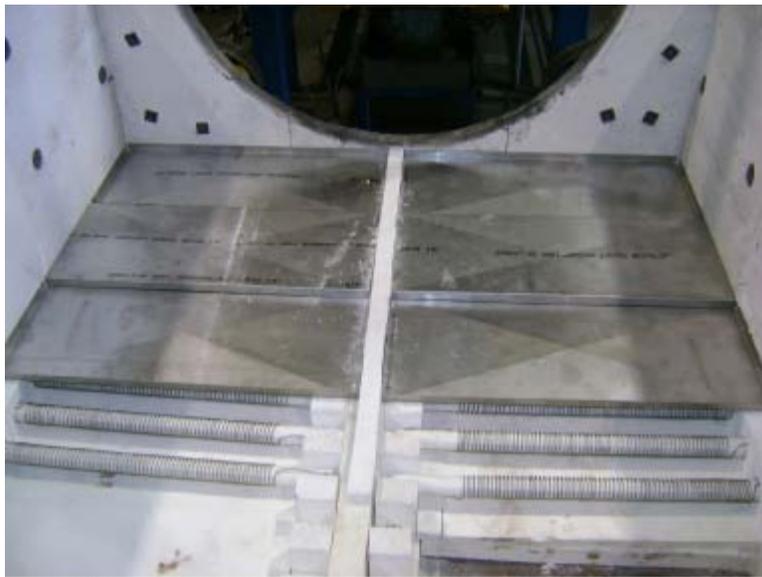
Once all the passage holes were drilled, it was possible to start installing the CoilCraft Element System (CCES). Basically a support structure was installed in the center of the furnace to both support and hold the elements in place to prevent electrical shorts and mechanical damage during assembly and for future element replacement operations. The elements were then slid in from both sidewalls into their respective niches. As the work progressed from one end of the furnace to the other, metal pans were installed to act as shields against product contamination.

Element Support System Installed, Elements Being Installed Through Sidewalls, Floor Insulation and Interlocking Contamination Shields Being Installed.

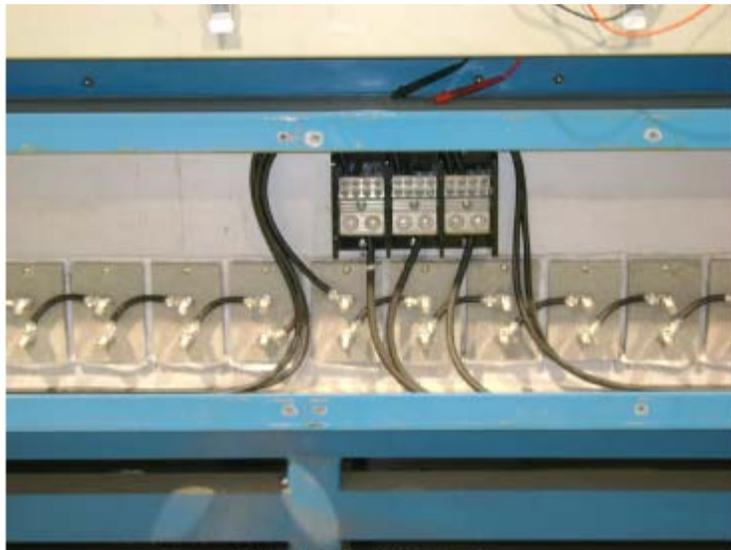
Once all the internal work was completed, a new power distribution block was added to one terminal compartment for ease of connecting the incoming three phase power lines from the power supply. A series of jumpers then had to be installed between various heaters. Those heaters were then connected via additional “bank” wiring to the power block, all in accordance with Thermcraft’s supplied drawings and instructions.

Power Distribution Block, Jumpers, and Bank Wiring Installed.

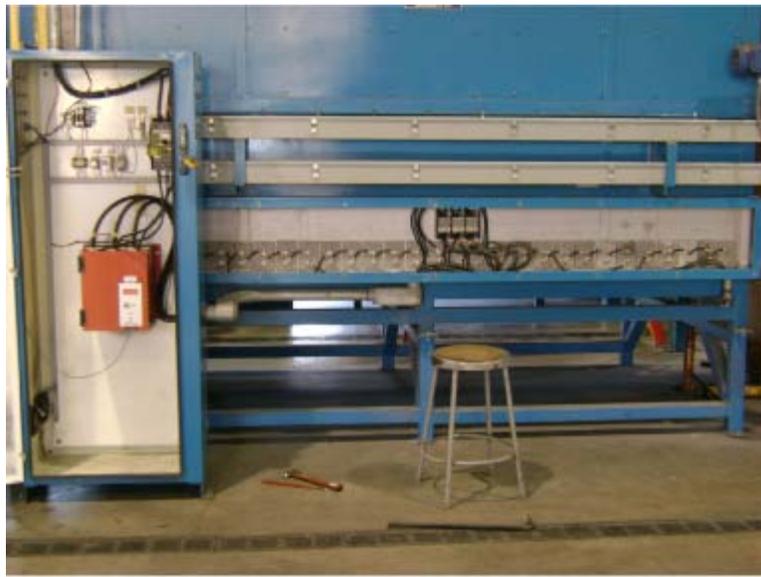
Once the above wiring was complete, the power supply was reconnected, all wiring checked again, and the system buttoned up.

Conversion Complete and Ready to Button UP
